Softbody Impact Resistance of Beryllium/Titanium Composite Blades

Detroit Diesel Allison
Division of General Motors Corporation
Indianapolis, Ind. 46241

May 1976

TECHNICAL REPORT AFAPL-TR-76-69
Final Report for Period July 1975 - March 1976

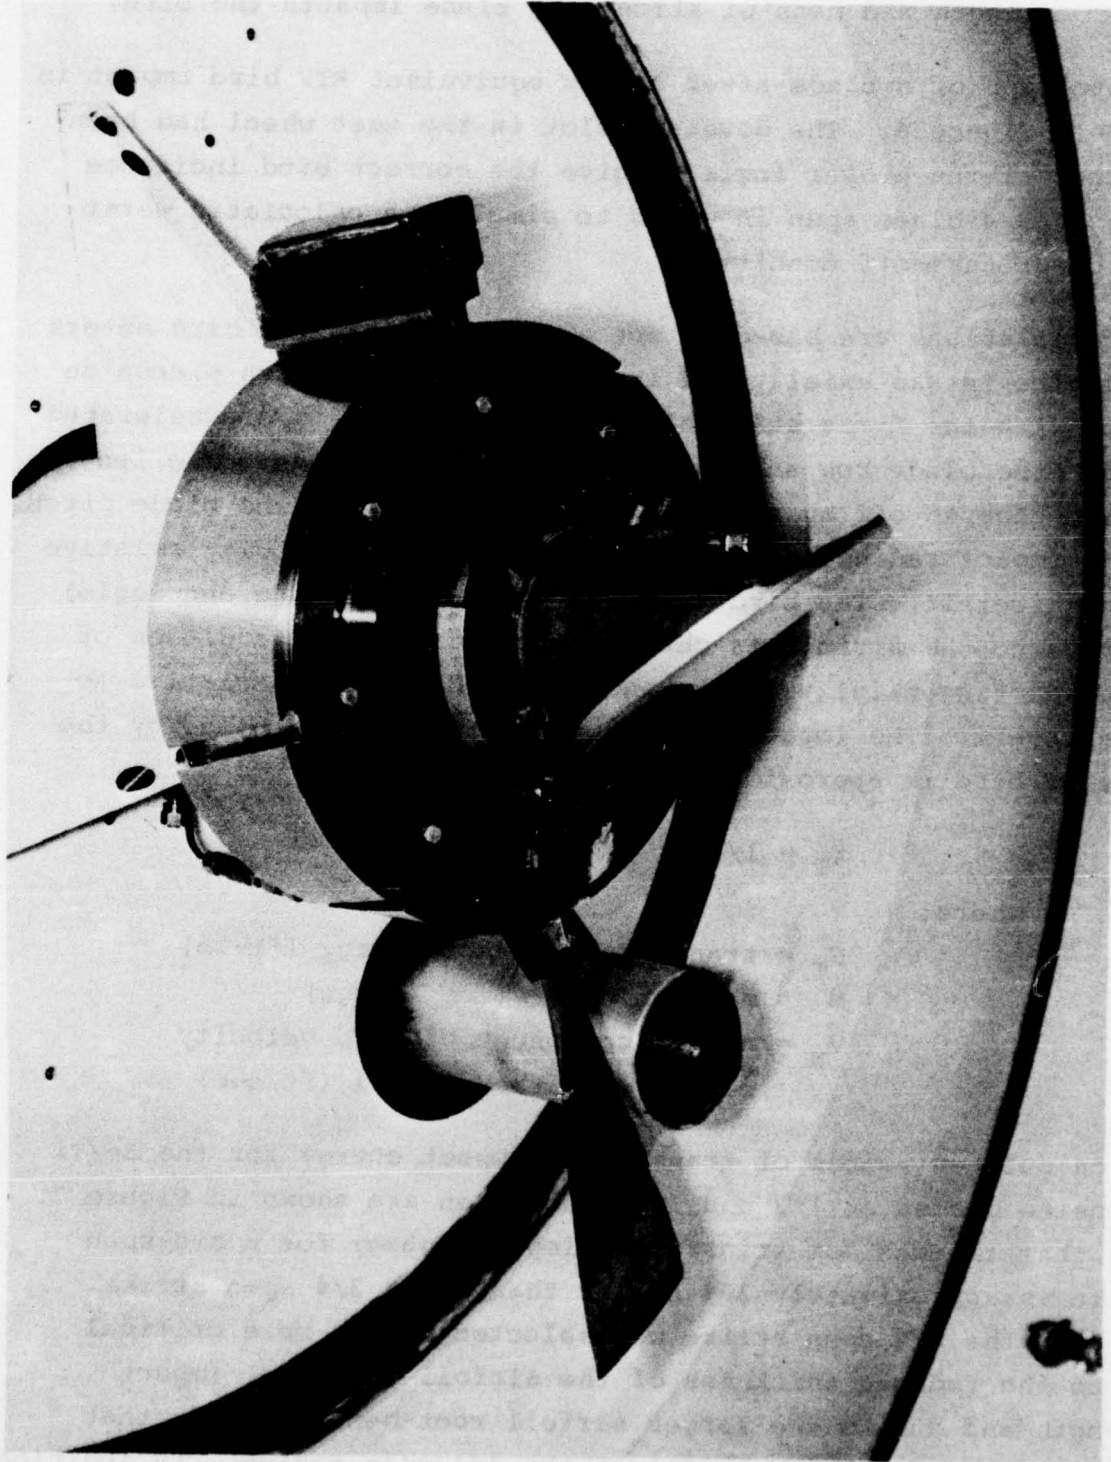
A photograph of a blade after a 3 oz equivalent RTV bird impact is shown in Figure 6. The dovetail slot in the test wheel had been machined at the proper angle to give the correct bird incidence angle at 3/4 blade span in order to simulate a calculated worst full-power take-off condition.

Figure 6. All Titanium Baseline Blade After 3 Oz. Impact.

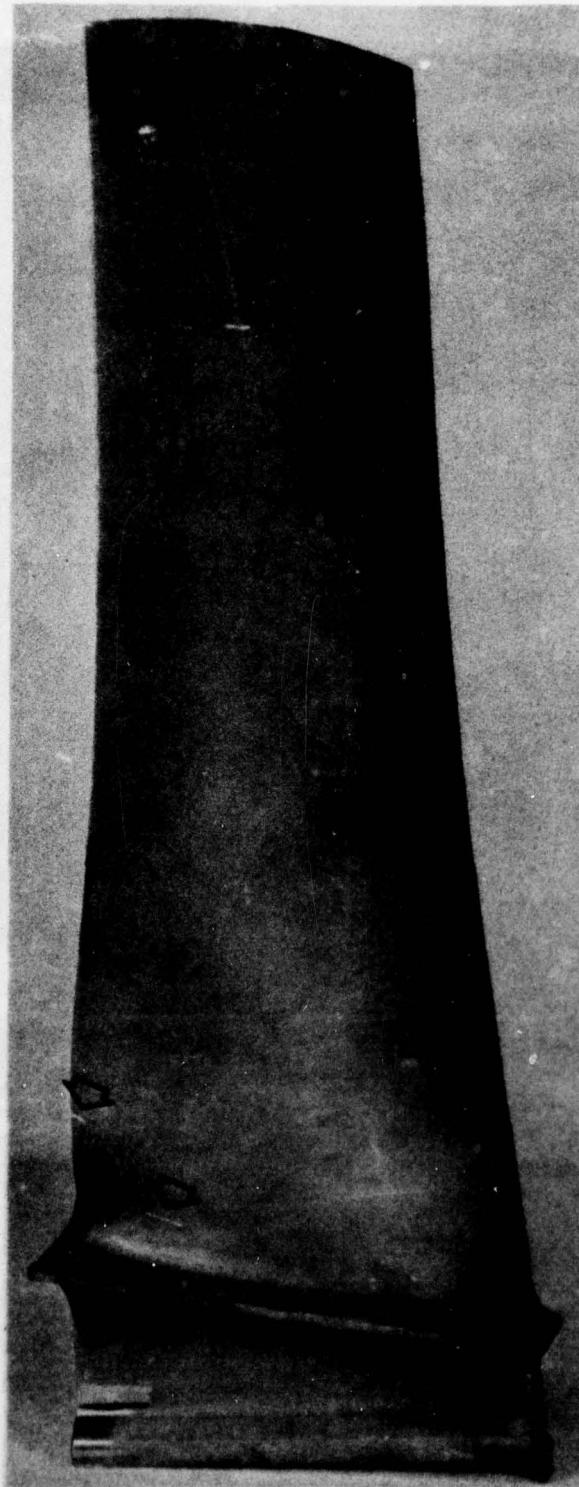
Fluorescent penetrant inspection indicated localized disbonding of the root blocks at the composite airfoil interface (see Figure 8). In fact, the overall quality of the diffusion bonding in this region was unknown and had been judged questionable. In order to partially demonstrate the structural soundness of the root block attachment, the decision was made to dovetail-pull test the two selected Be/Ti rod blades. A load equal to 120% of maximum airfoil design load was selected as the upper limit to be applied to the airfoil and this was found to equal 100% dovetail design load or 51,000 lbs. The dovetail-pull testing was accomplished with a test setup similar to that shown in Figure 9, but without the dial indicators. The upper part of the airfoil was held in the close-fitting steel clamping fixture by epoxy glue. The dovetail was positioned in a dovetail slot that was machined to the proper attachment geometry.

Figure 8. Fluorescent penetrant indications of localized root
block-airfoil disbonds (Magn: 2/3X)

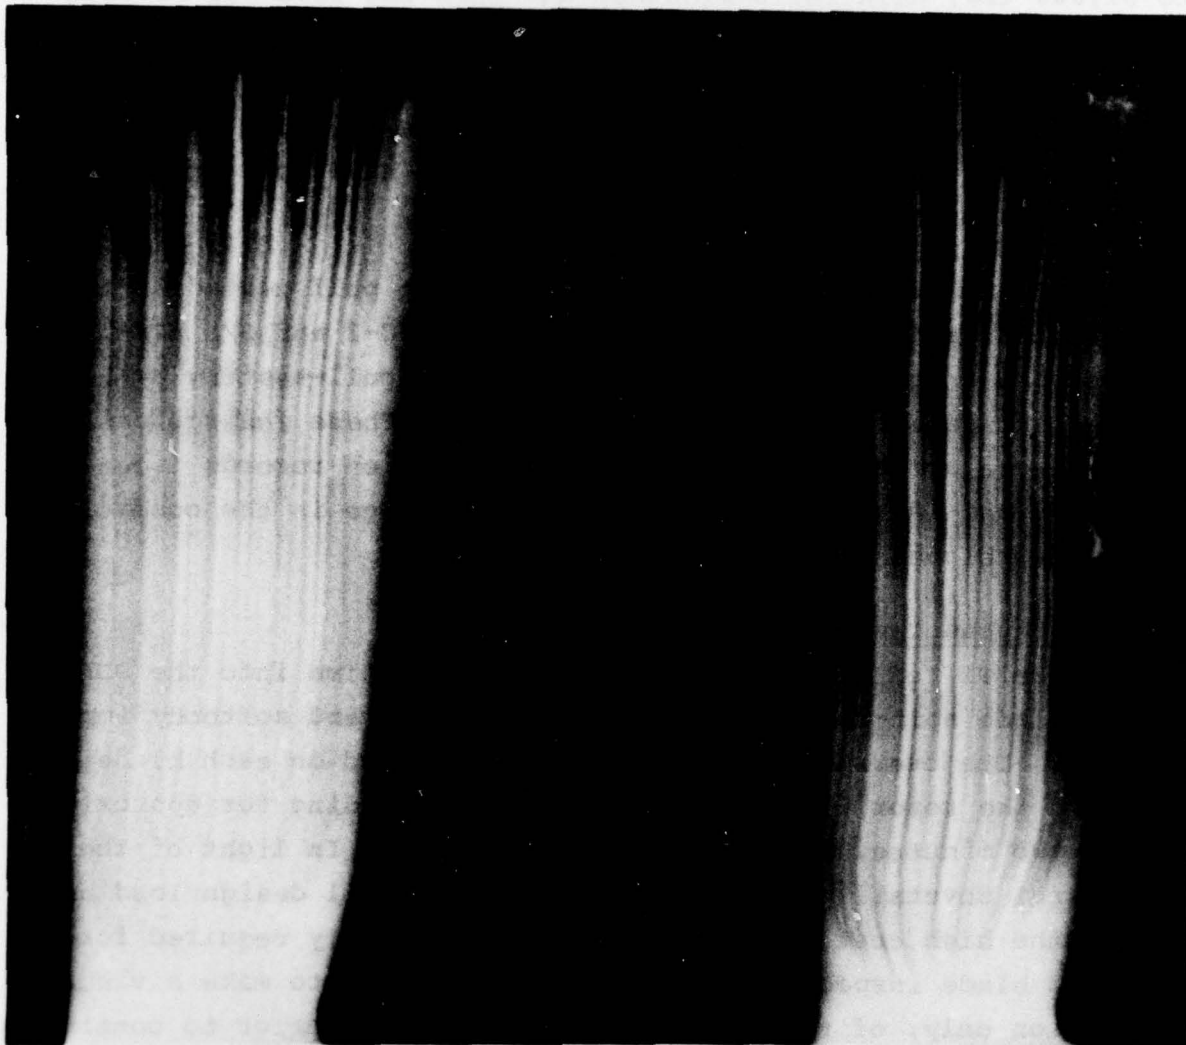
Figure 10. Radiographs of Be Rod/Ti Composite blade E24-1 after finish machining.

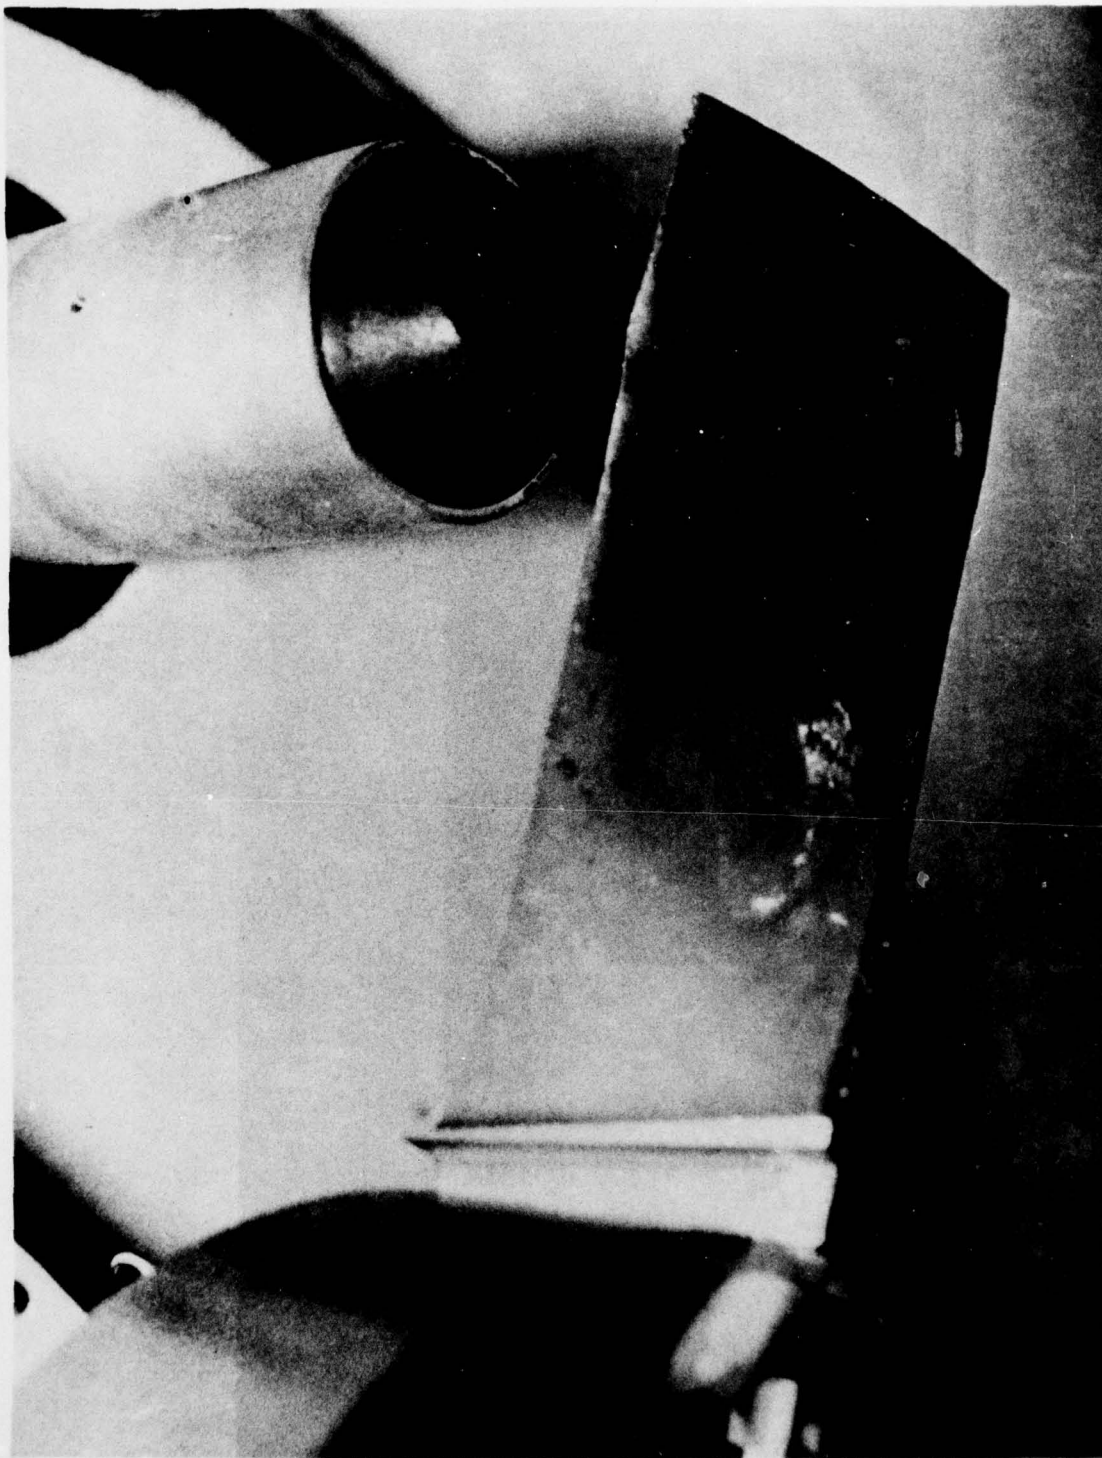
The blade damage due to the 3 oz and 2 lb equivalent baseline impacts are shown in Figures 11 and 12. Impact damage due to the 4 lb duck shot into the running engine is shown in Figure 13. Blade local damage due to the single-blade 2 lb equivalent RTV bird impact is more severe than that obtained from the 4 lb duck impact in the engine. The maximum blade tip deflection that occurred during the engine test is estimated from the high speed photos to be 3.50 inches. Detailed study of the single-blade 2 lb RTV bird impact high speed movies gave a maximum tip deflection of approximately 2.0 inches. Based on these observed deflections, the DDA 4 lb duck full rotor engine test should be about 1.8 times more severe than the 2 lb equivalent RTV bird impact test. The difference in local damage between the engine test and single blade test is thought not to be due to a poor simulation of bird material but rather due to the very positive way in which the RTV 560 bird is held in position by the piston bird holder in the single blade test.

Figure 11. All Titanium baseline blade after 3 oz. impact

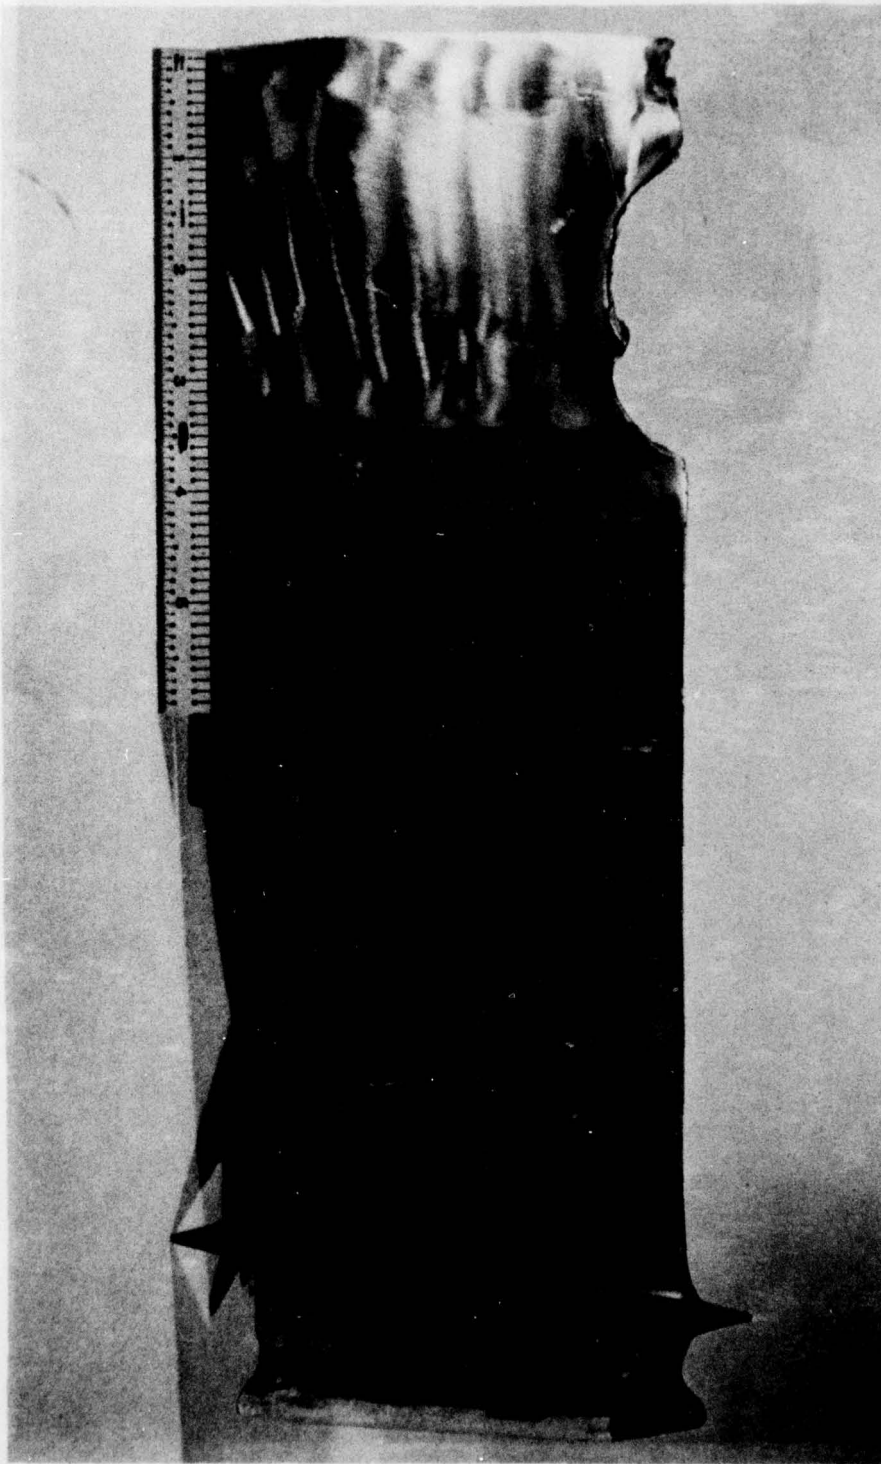
Figure 12. All Titanium baseline blade after 2 lb. impact

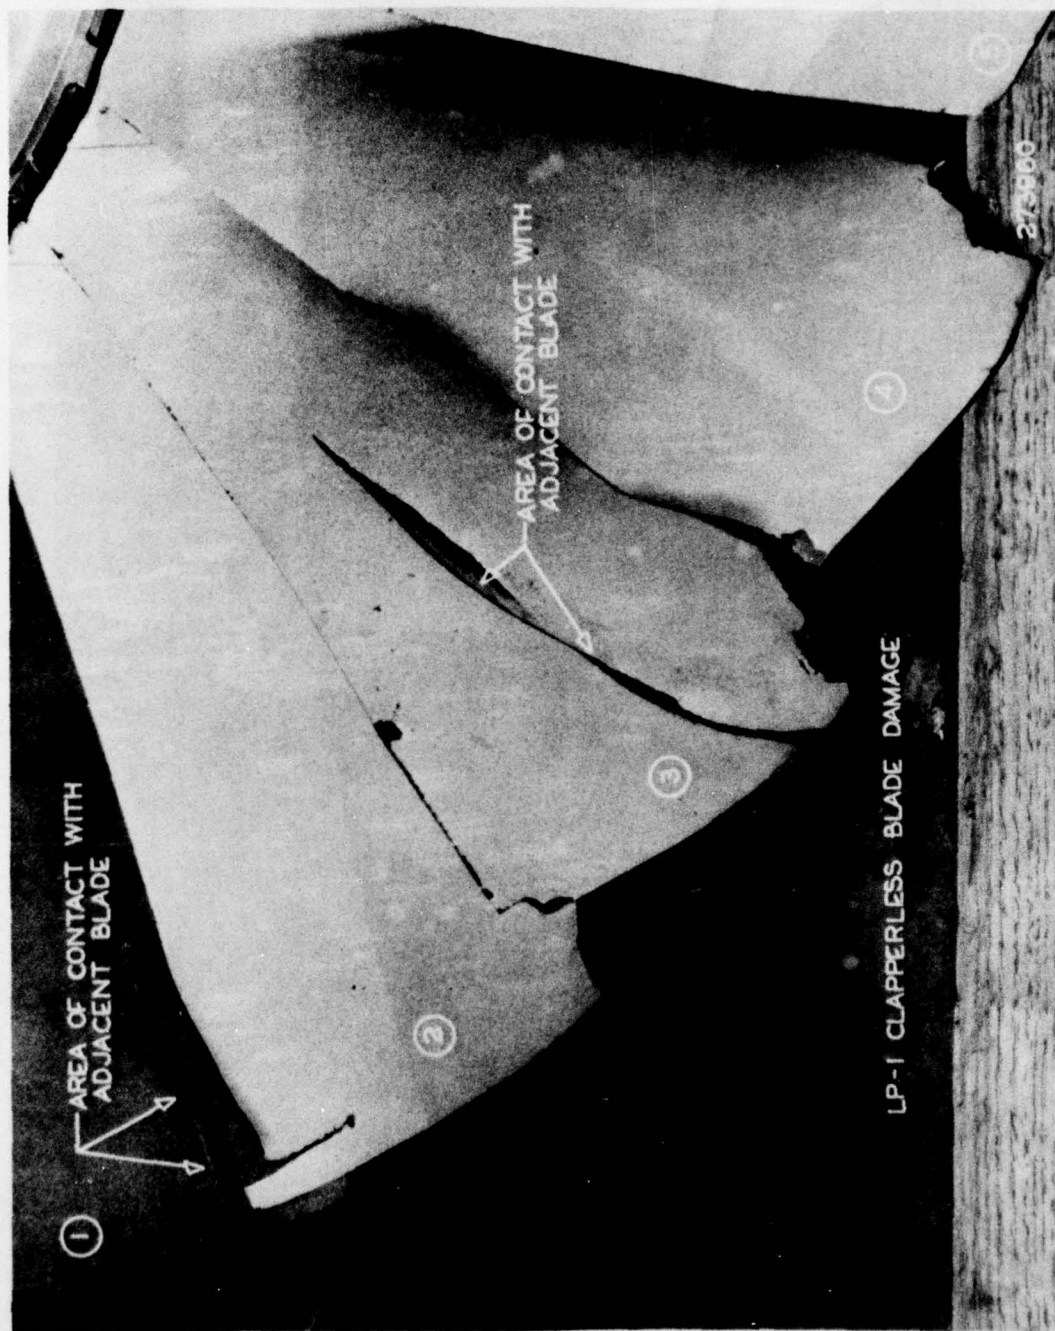
Figure 13. Blade Damage After 4 lb. Bird Impact In An Engine

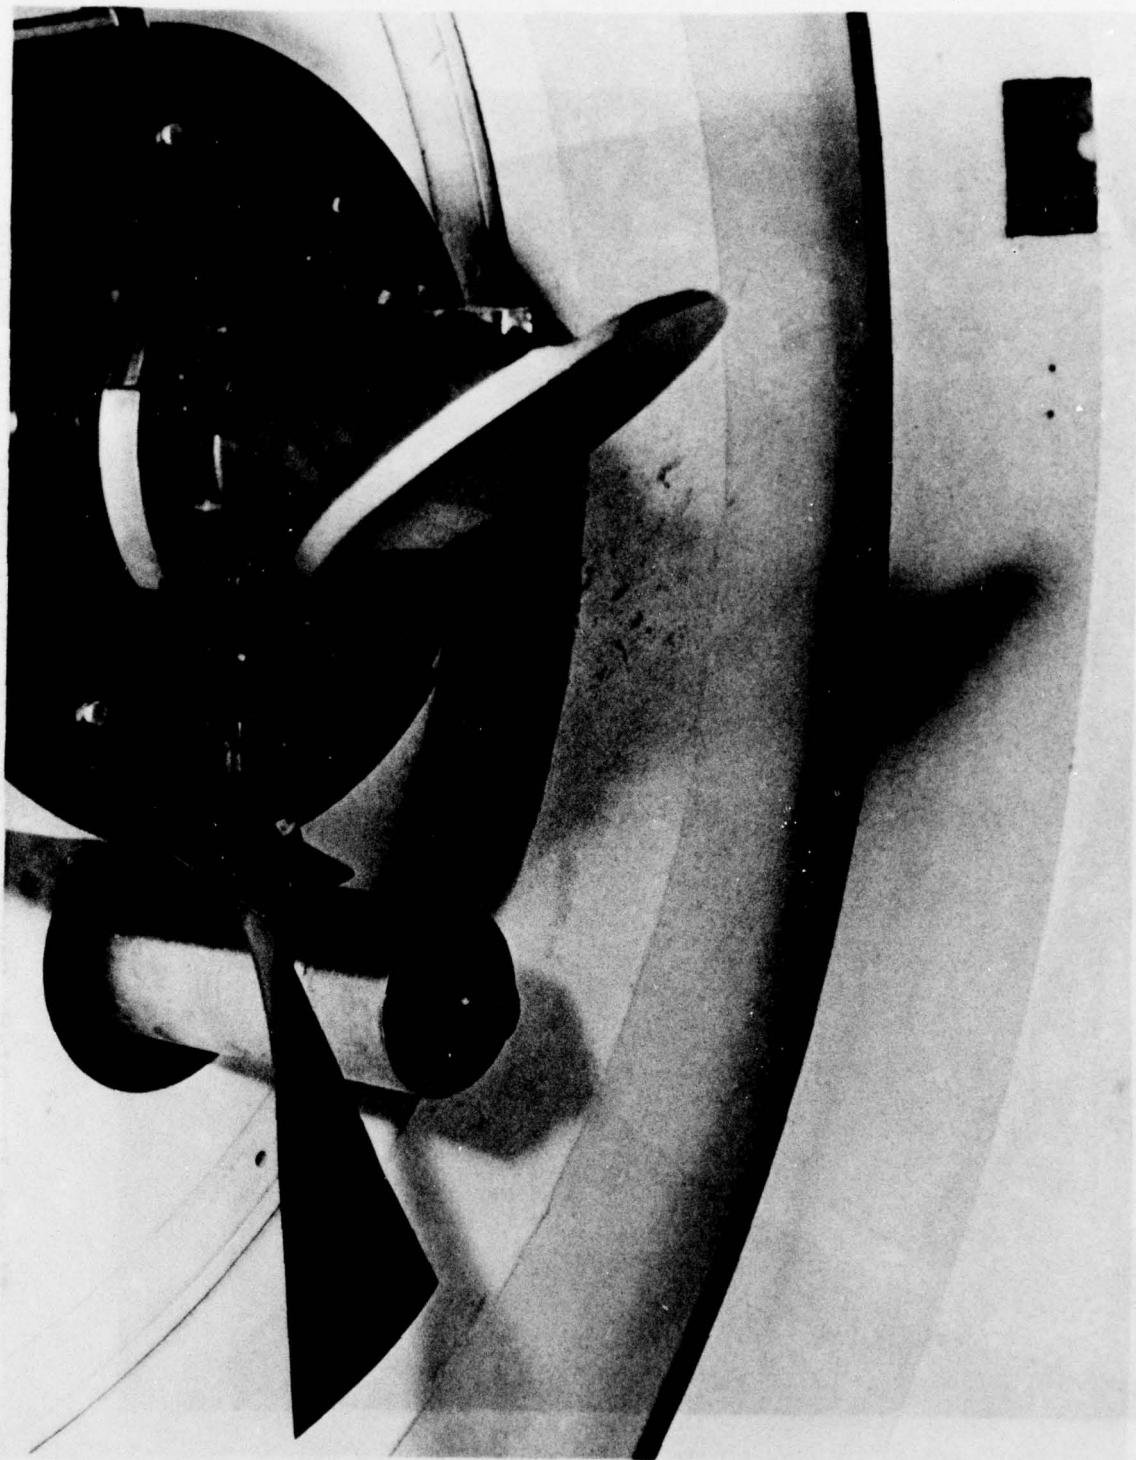
A simple check sheet was reviewed as the rotor was brought up to 100% speed followed by triggering the release for the 3 oz bird impact. All components performed well and the condition of the blade after the 3 oz equivalent shot is shown in Figures 14 and 15. Note the slight bend in the airfoil leading edge. The high speed

Figure 14. S/N E24-1 Be/Ti blade after 3 oz. impact, View 1

- o The structural integrity of blades S/N E24-1 and S/N E23C-3 was demonstrated by overspeed testing to 110% design speed.
- o Blade S/N E24-1 withstood a calculated 3 oz equivalent size bird impact with only slight leading edge damage. This was followed by a calculated 2 lbs equivalent size bird impact where the blade essentially remained in one piece with the leading edge portion bending away from the main airfoil along a radial split or fracture. The bird injection gun misfired and prevented the high-speed movies from being taken, however the bird holder was down in the correct position at impact to give the correct amount of bird slice. The radial splitting type failure of the blade leading edge should have been expected due to the lower strength of the composite in the direction normal to the radially-configured Be rods. The use of an orientation other than uniaxial could increase the

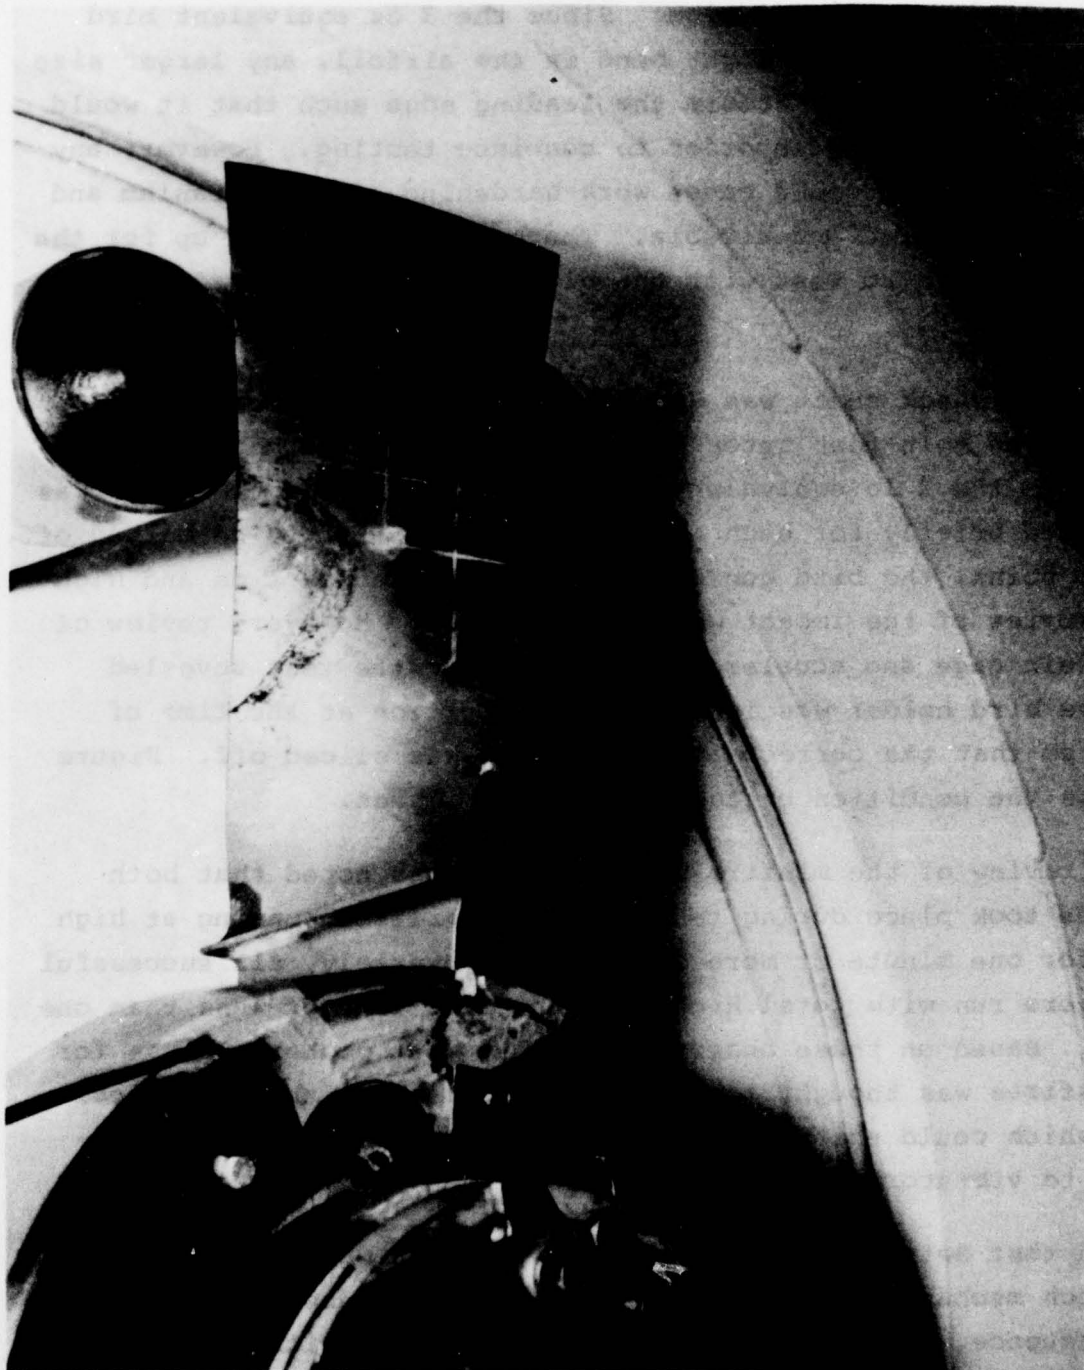
Figure 15. S/N E24-1 Be/Ti Blade After 3 Oz. Impact, View 2

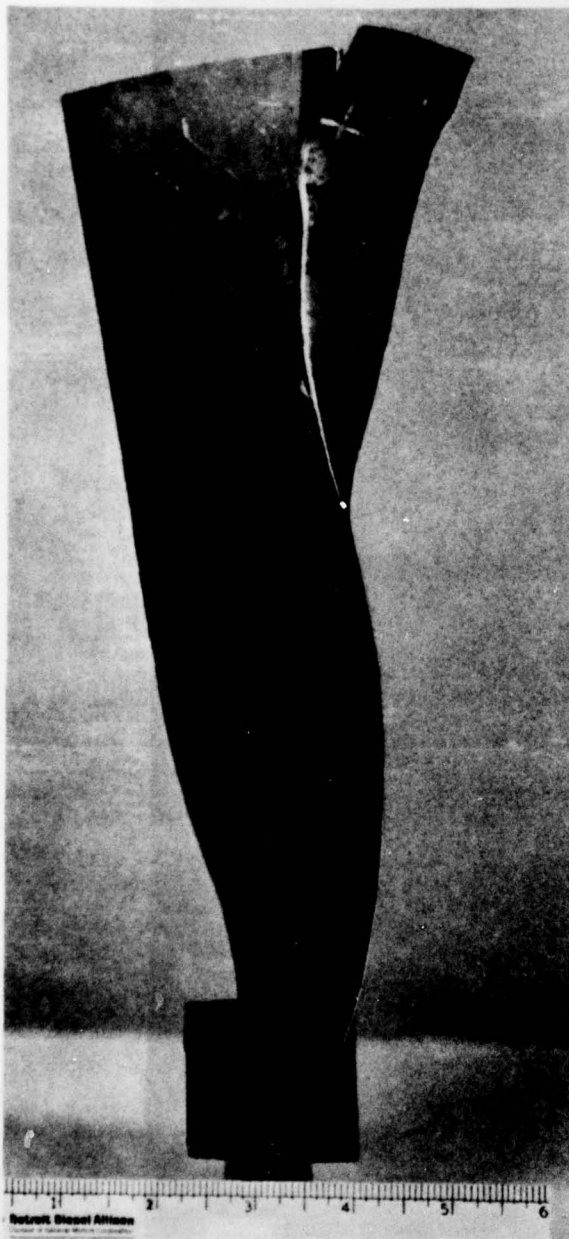
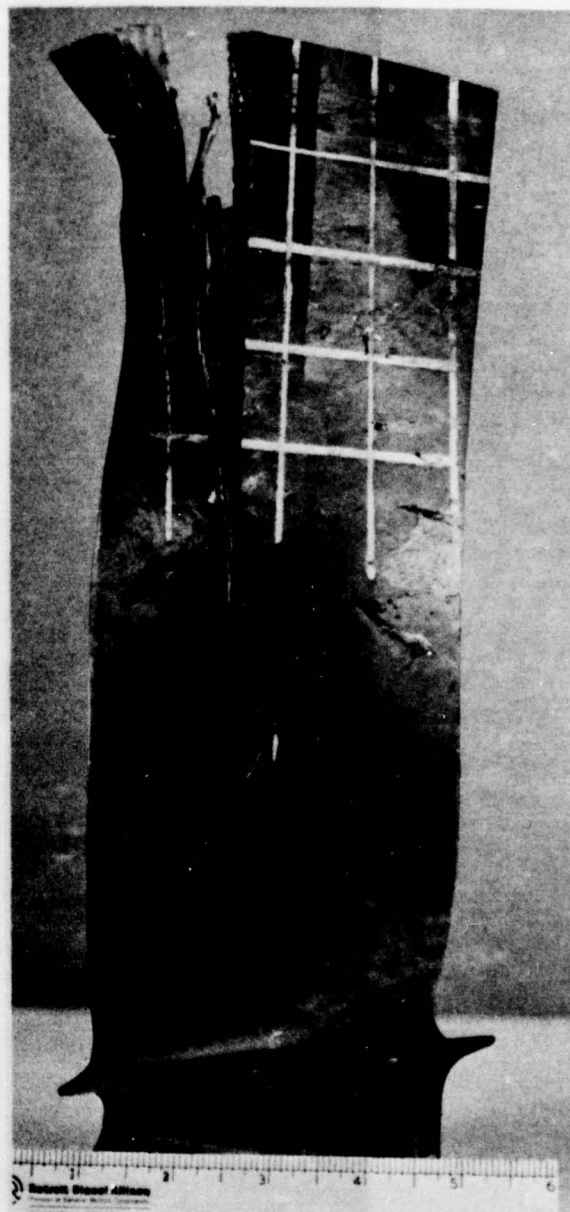
The written check sheet was expanded to cover all functions in more detail. The spin-test rotor was brought up to just below 100% speed with the 2 lb equivalent RTV bird loaded and the speed was stabilized briefly for each item on the check list to be marked off. At this point, the bird gun misfired for the second time and high speed movies of the impact were not obtained. However, review of the strain gage and accelerometer data after the test revealed that the bird holder was in the proper position at the time of impact so that the correct amount of bird was sliced off. Figure 16 shows the condition of the blade after impact.

Figure 16. S/N E24-1 Be/Ti blade after impact with 2 lb bird

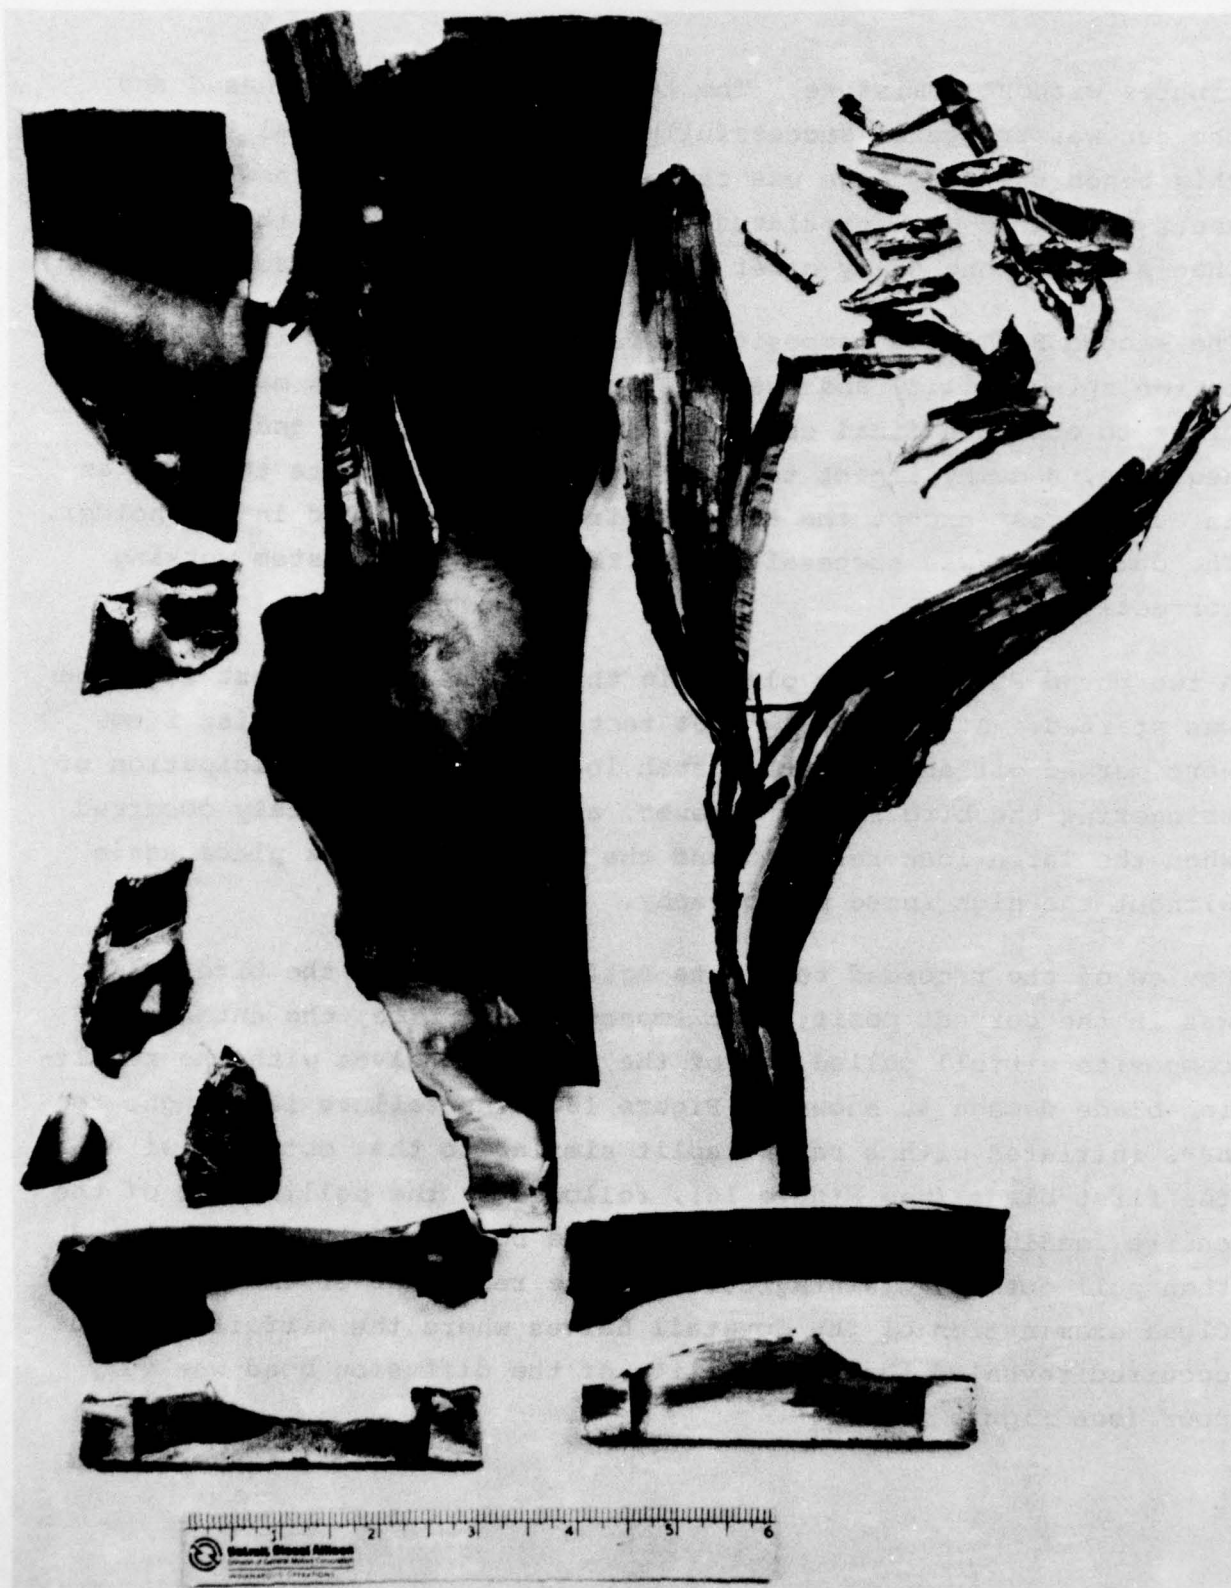
Review of the recorded test data again showed that the bird holder was in the correct position at impact. This time, the entire composite airfoil pulled out of the dovetail halves with the resulting blade damage as shown in Figure 18. The failure is thought to have initiated with a radial split similar to that obtained with the first blade (see Figure 16), followed by the pulling out of the entire leading edge portion down to the bottom of the dovetail and then pull out and disintegration of the remainder of the airfoil. Close examination of the dovetail halves where the airfoil pull-out occurred revealed that the quality of the diffusion bond was very poor (see Figure 18).

Figure 18. S/N E23C-3 Be/Ti Blade after 2 lb. impact

- o The blade S/N E23C-3 airfoil completely pulled out of the blade attachment during the 2 lbs equivalent size impact. A gun latch-locking mechanism had been incorporated to prevent misfire, but misfire accidentally occurred again and as a result high-speed photography was not obtained. The bird holder again injected into proper position for impact. Examination of the attachment halves after failure revealed a very poor quality of root bonding and this is considered to be the significant factor contributing to the total failure of S/N E23C-3. Good attachment bonding is essential to the satisfactory performance of the Be/Ti rod blades.

- o Further development of the DDA softbody single-blade impact procedure is required, particularly for the bird injector triggering mechanism and the bird holding system. An alternate bird material should be considered.
- o Blade fabrication processes could be developed that provide for

a positive attachment of the root to the airfoil.
